Scan Before You Replace Non-Destructive Moisture Tests Provide Valuable Information for Roofing Professionals

By Brian Lambert

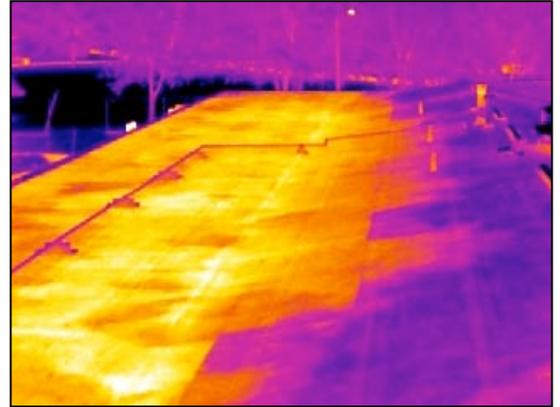
Infrared Thermography, also known as an IR scan, is a non-destructive test method to detect and record temperature differences across the surface of an object. IR scans are the most common moisture detection method for identifying wet insulation on commercial roofing systems. During the day, wet insulation will absorb much more heat energy than dry insulation. At night, this heat is retained in the wet insulation longer and is released slower into the atmosphere. Most IR scans are done at night in order to capture this thermal signature of wet insulation trapped in a roofing system. It is common to precisely mark these damaged areas of wet insulation with spray paint on the roof surface. A CAD drawing is then produced identifying wet areas throughout the roof sections.

IR scans work best when conditions provide for a distinct temperature difference between the interior and exterior of the building. Additionally, optimal conditions are at night following a sunny day and when nighttime temperatures cool quickly. The greater the rate of outside temperature change, the greater the difference in surface temperatures between the wet and dry areas.

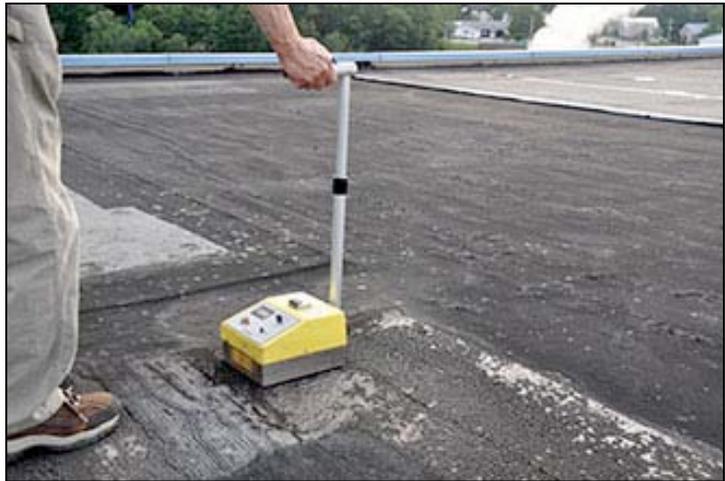
The readings are used to create a map of the wet areas on the roof plan, which again show the location and outline of the suspected wet areas. Areas with wet insulation will have greater concentrations of hydrogen than those with dry insulation. This method of data collection shows where the moisture level is highest, allowing the source of the leak to be more easily determined.

With nuclear roof scans, the entire roof is typically marked in a 5' x 5' or 10' x 10' grid pattern. Within each grid point, a reading is taken and recorded on a roof plan. The smaller the grid pattern, the more data points are collected. For example, a 10,000 square foot roof with a 10' x 10' grid would require 100 data points. If the grid were 5' x 5', there would be 400 data points.

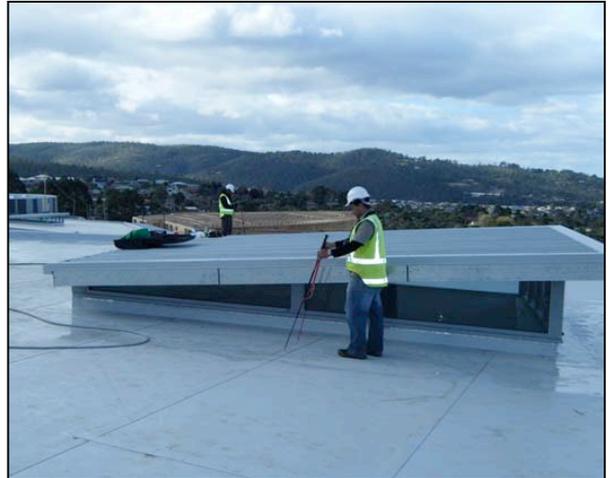
One advantage of EFVM is that once the point of entry is detected, it can be repaired and then retested the same day to ensure that the leak point has been repaired accurately. Although EFVM can be used on a variety of low slope roof systems, it is most often used on roofs where finding a leak poses difficulties, such as vegetated roof systems, ballasted single plies, and inverted roof membrane assemblies.
